Manhole Inspection Summary

Manhole # S55C__006MH

Insp Date: **6/20/08 2:20 PM**

Location Address: **rear 3536 e fairmount ave**

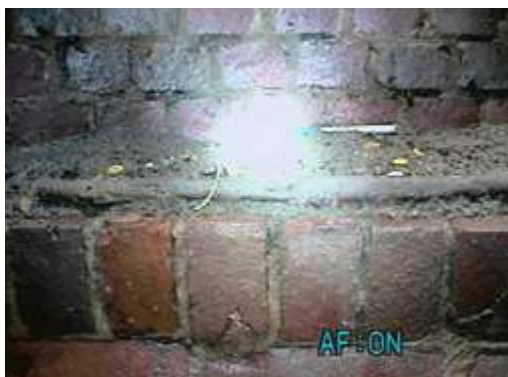
bench debris

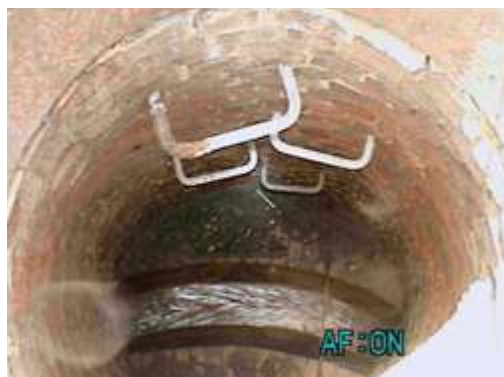
Defect 2

Count: **2** Missing: **0** ☒ **Corroded**

steps

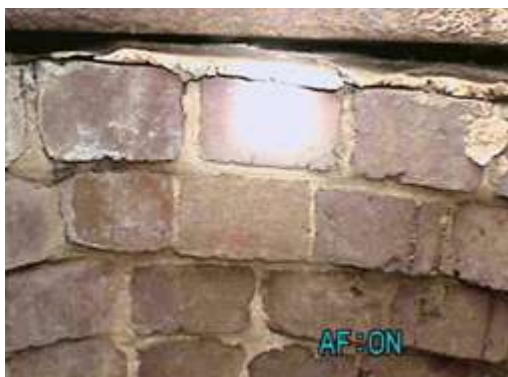
Defect 1

Condition: ☐ Sound ☒ **Cracked** ☐ Root Intrusion ☐ Loose Brick ☒ **Deteriorated**

frame adj & a crack in chimney

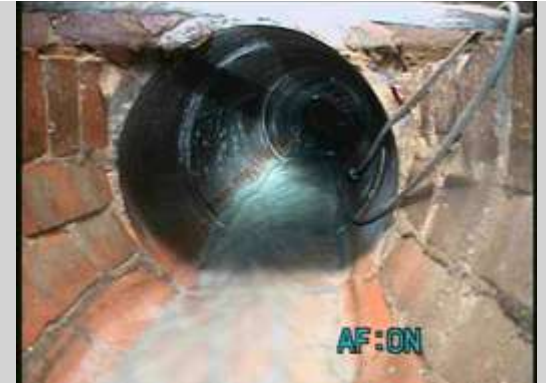
12 O'Clock Outflow

8 in. Circular Gravity Sewer
Pipe Out @ 12 O'Clock

Pipe Material: **Clay** ☐ Pipe Lined

Invert Depth: **8.89** (ft.) Flow Characteristics: **Fast**

Deposits: ☒ None ☐ Mud ☐ Sludge ☐ Debris ☐ Grease

Infiltration: **None** Pipe Seal Cond: **Unknown**

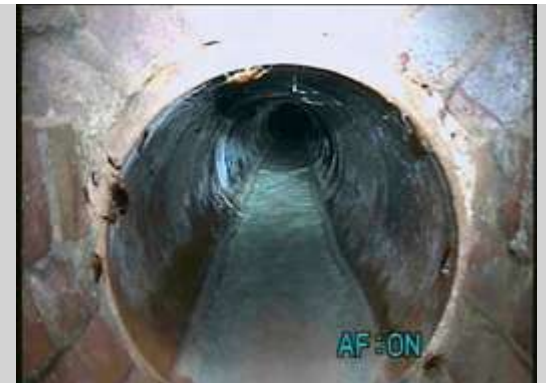
5 O'Clock Inflow

8 in. Circular Gravity Sewer
Pipe In @ 5 O'Clock

Pipe Material: **Clay** ☐ Pipe Lined

Invert Depth: **8.85** (ft.) Flow Characteristics: **Fast**

Deposits: ☒ None ☐ Mud ☐ Sludge ☐ Debris ☐ Grease

Infiltration: **None** Pipe Seal Cond: **Unknown**
